**PRELIMINARY ASSESSMENT
WITH SAMPLING**

DEVOE MARINE COATINGS

2625 Durahart Street
Riverside, California 92502

Greg Sweel, Senior HS Engineering Geologist
Rania Zabaneh, Hazardous Substances Engineer

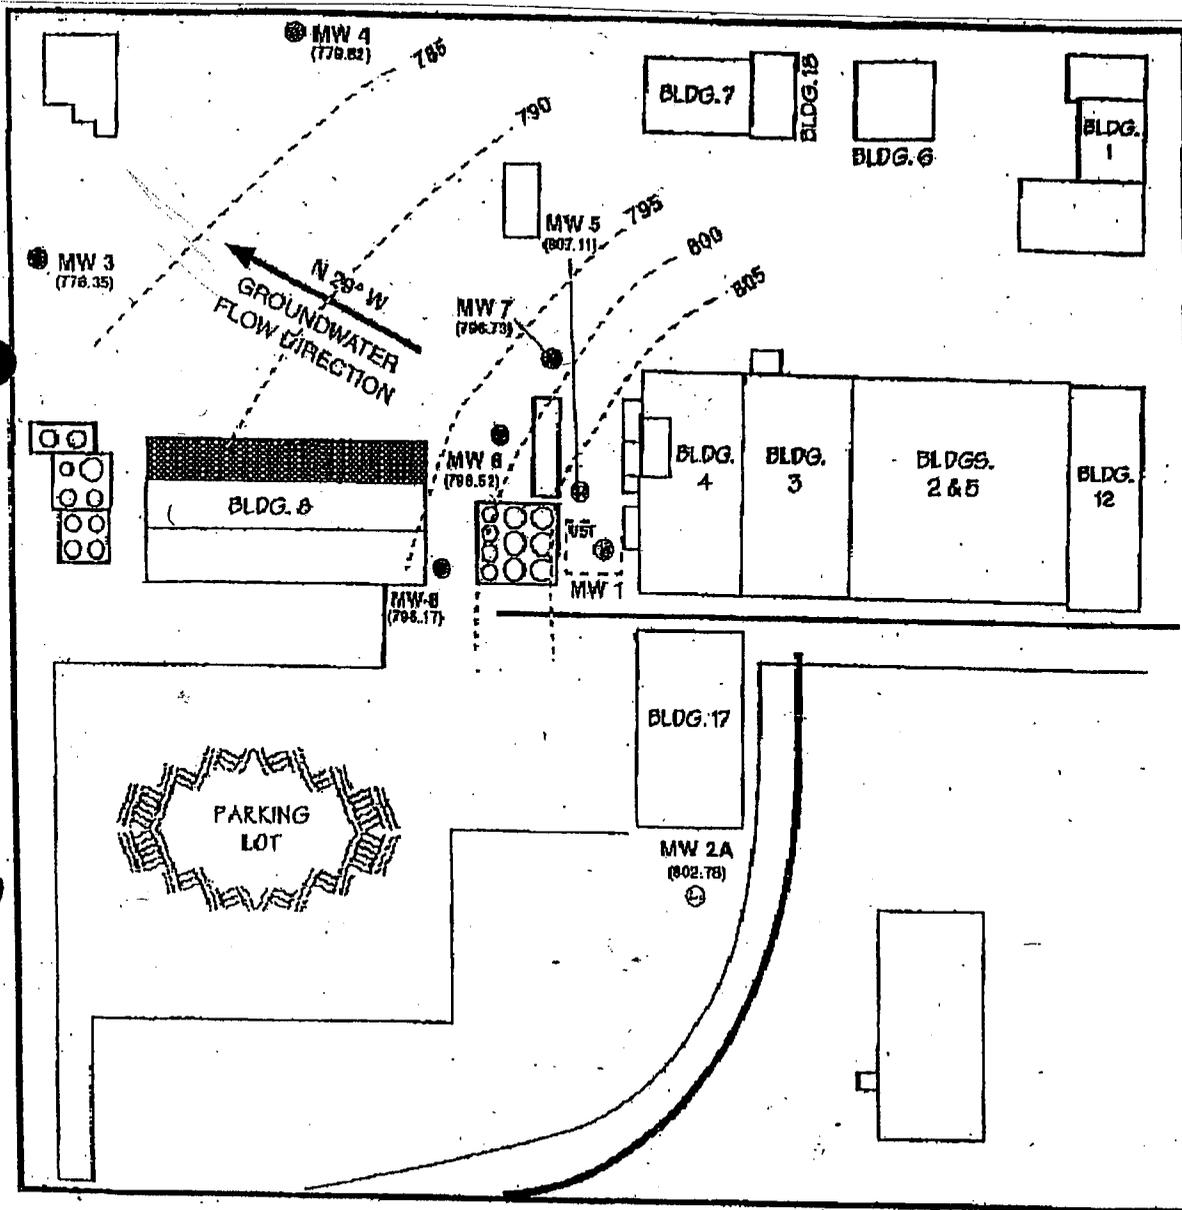
- (802.78) GROUNDWATER MONITORING WELL AND GROUNDWATER ELEVATION IN FEET ABOVE MEAN SEA LEVEL.
- LINE OF EQUAL GROUNDWATER ELEVATION ABOVE MEAN SEA LEVEL.

Measured April 21, 1997

From the locations of the monitoring wells and the depth measurements at each well, groundwater flow is considered to move in a northwesterly direction. (Note: Assumed the surveyed well elevation reference datum was accurate). Also, the SVE system was operating when water level measurements were made and the resultant measurements may not reflect static conditions.

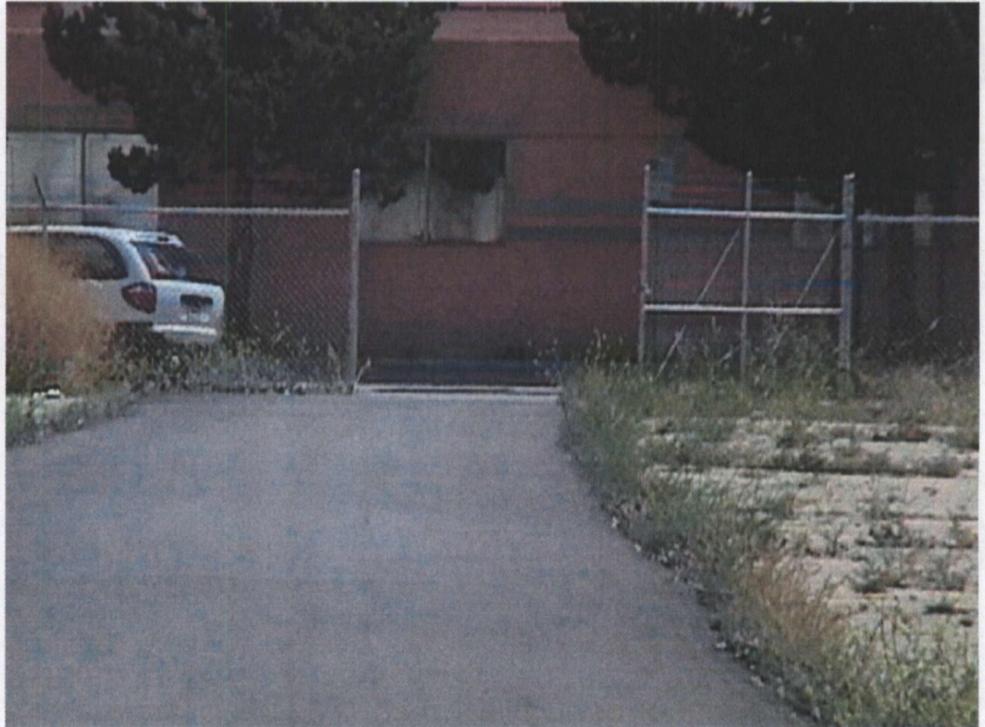
Photograph taken from the inside of the former Devoe facility of the front gate towards the eastern direction.

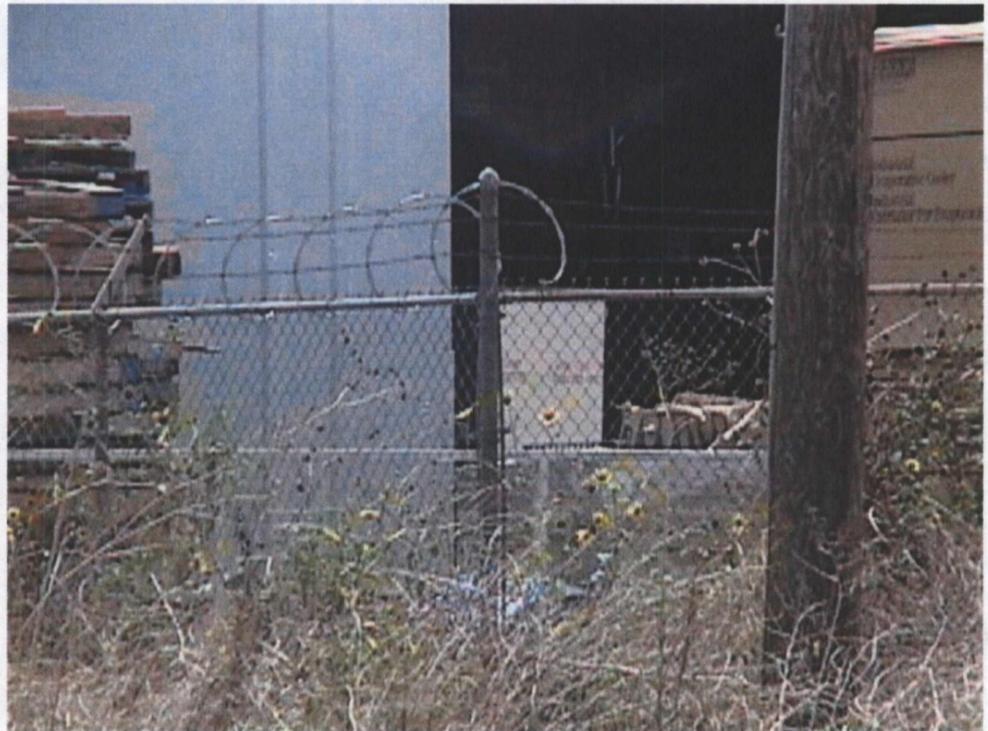
Photograph taken of southern chain-link fence topped with the barbed wire.

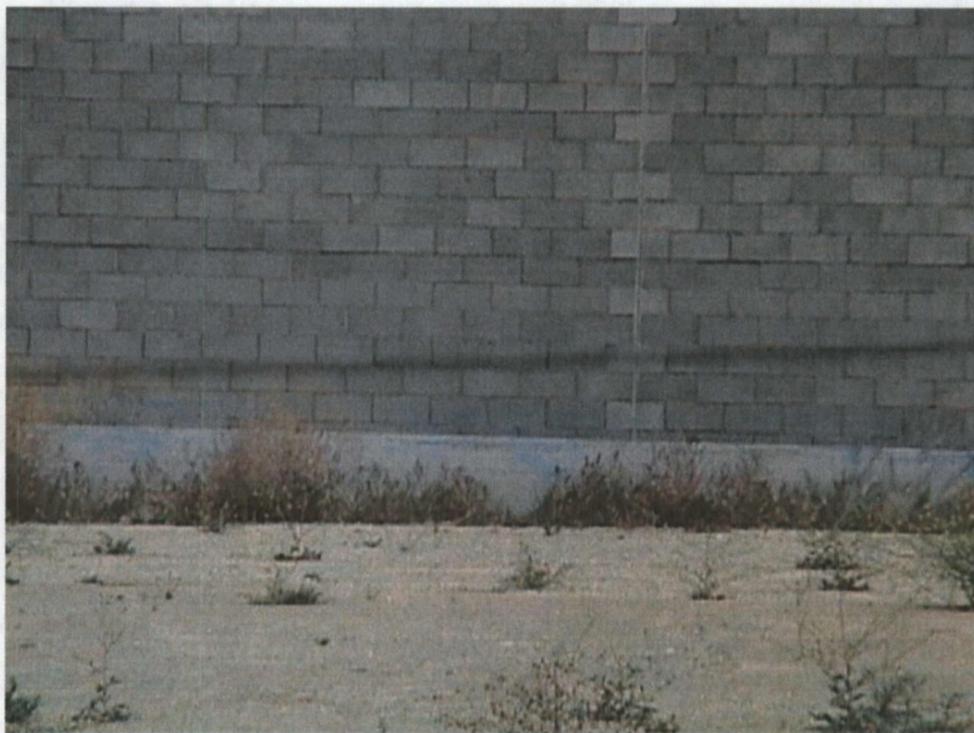
Photograph taken of the northern low (light blue) concrete wall in front of the high concrete wall of the adjacent property to the north of the former Devoe facility.

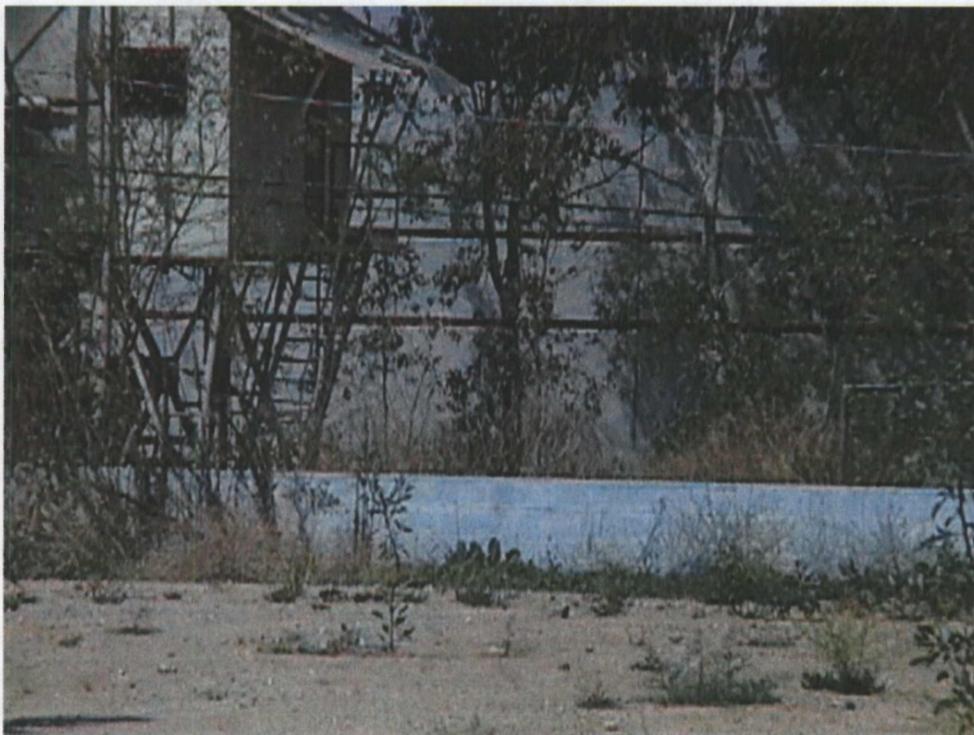
Photograph taken of the western low (light blue) concrete wall surrounding the former Devoe facility and neighboring the abandoned cement company to the west.

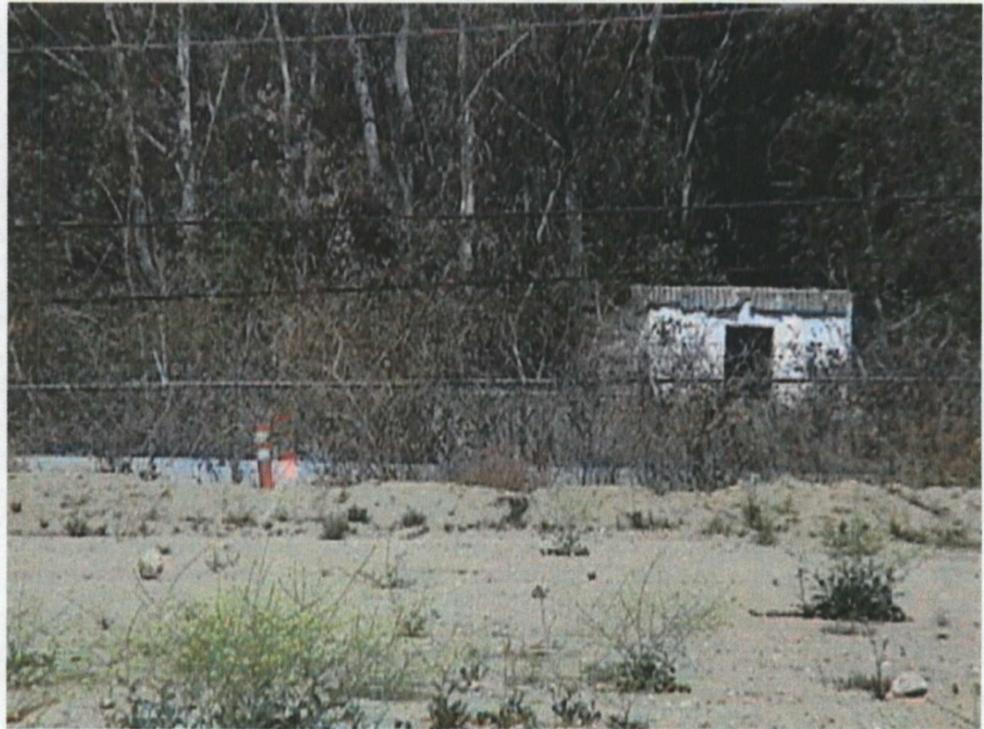
Photograph taken of the Devoe site after all the buildings were removed and the site is all dirt and spread with sparse vegetation.

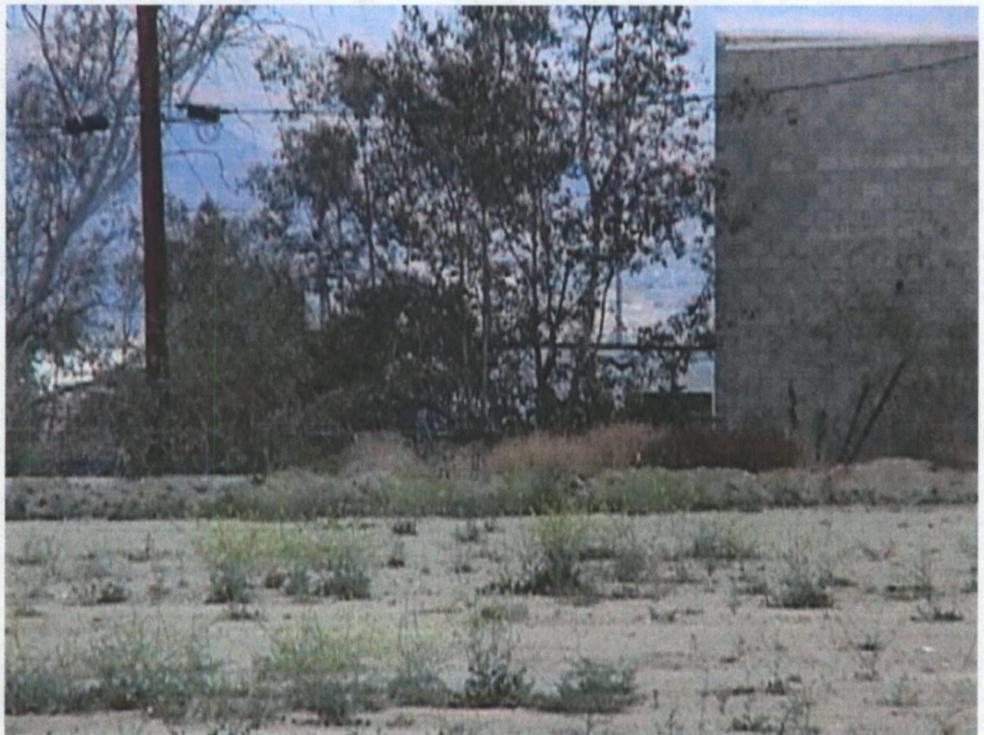
Another view taken of the dirt and sparse vegetation of what used to be the Devoe facility.

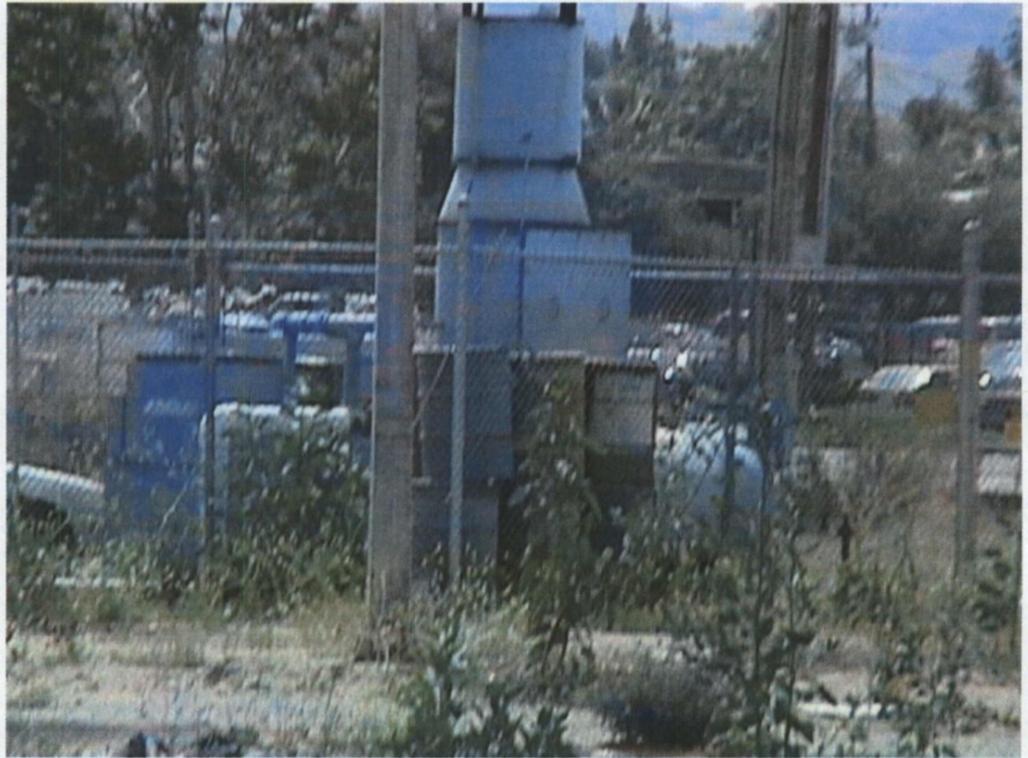
Photograph taken of the Soil Vapor Extraction System (Thermal Oxidizer Unit) on-site permitted by the South Coast Air Quality Management District.

Several groundwater monitoring and soil vapor extraction wells, and a Soil Vapor Extraction (SVE) / Thermal Oxidation (TO) unit are still present, operating, and detecting residual contamination at the Site.

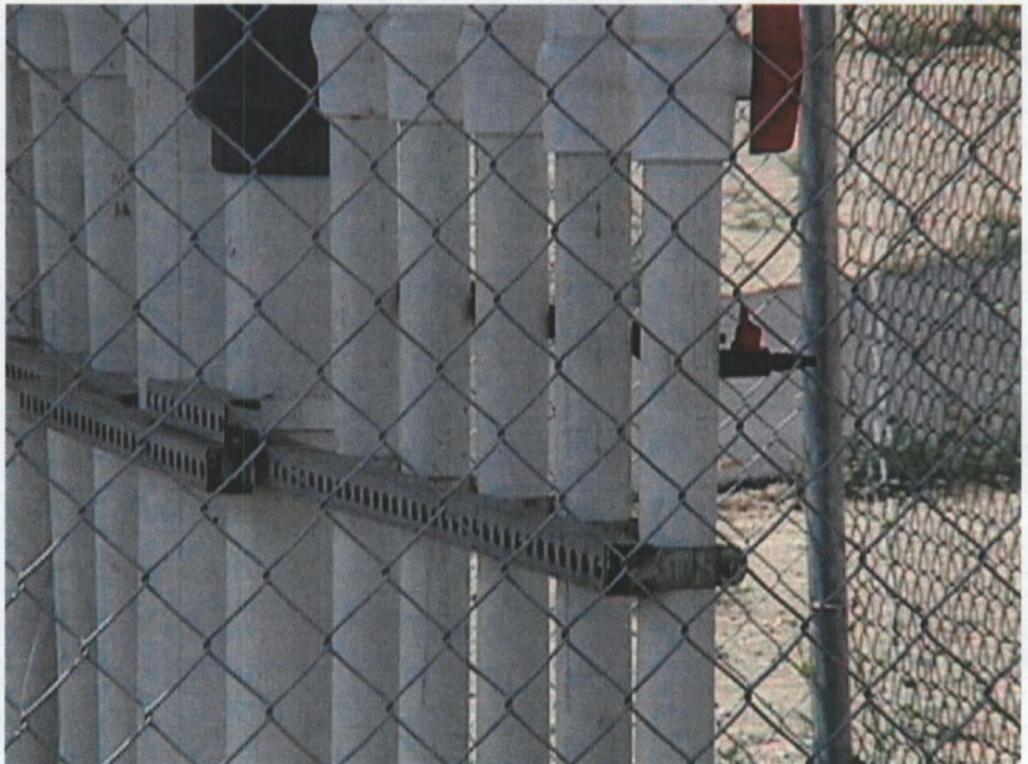
Photograph of the vapor extraction well manifold adjuster.

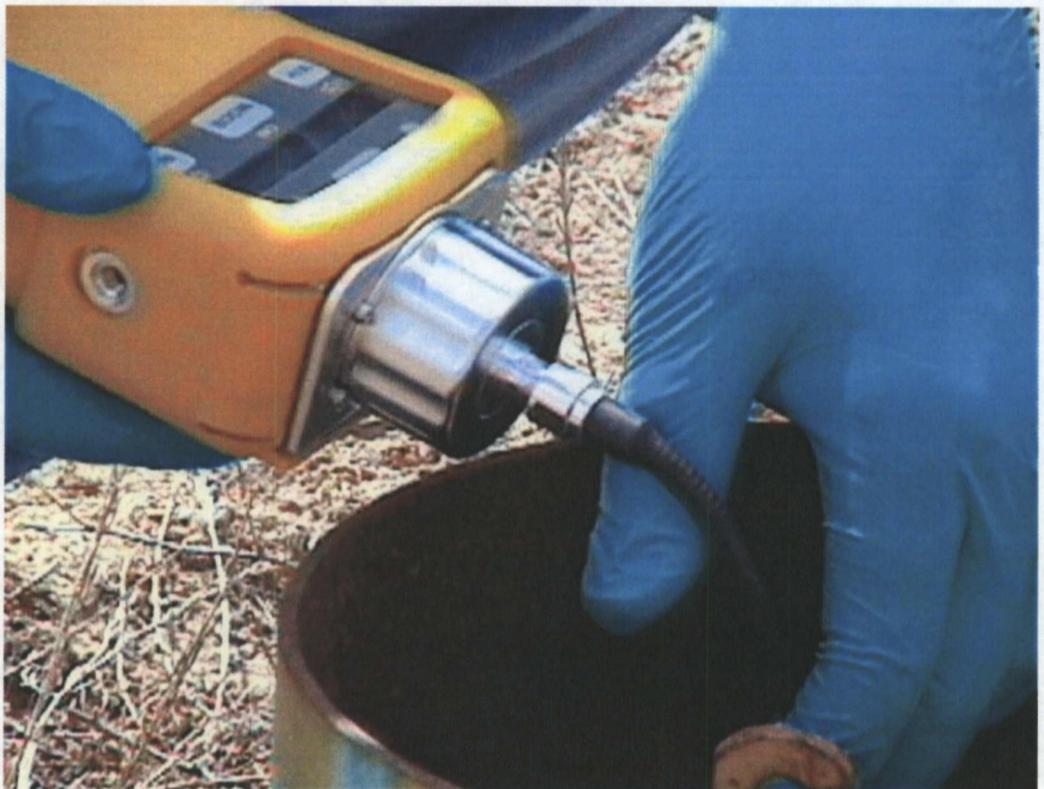
Using the PID unit to take reading measurements of monitoring wells before collecting groundwater samples using bailers.

Groundwater samples were collected from monitoring wells MW-1 and MW-5. These particular wells are in close proximity to the former UST area and have historically been the most consistently impacted by site related constituents. Two (2) samples were analyzed for VOCs, while another two (2) were analyzed for a full scan of metals. No free product or visible sheen was encountered in either well. EPA Method 8260 was chosen for VOC analyses, while EPA Method 6010 was chosen for metals scan. Sample analysis was conducted by DTSC's Hazardous Materials Laboratory (HML) in Berkeley, California. Total xylenes were detected at a concentration of 102,000 $\mu\text{g/l}$ in MW-1, but were not detected above laboratory quantitation limits of 5 $\mu\text{g/l}$ in MW-5. Total chromium was detected at a concentration of 198 $\mu\text{g/l}$ in MW-1 and 184 $\mu\text{g/l}$ in MW-5. The Federal MCL for total chromium is 100 $\mu\text{g/l}$ (In California, the MCL is 50 $\mu\text{g/l}$). Refer to the laboratory analytical results provided in Appendix G (Analytical Results).

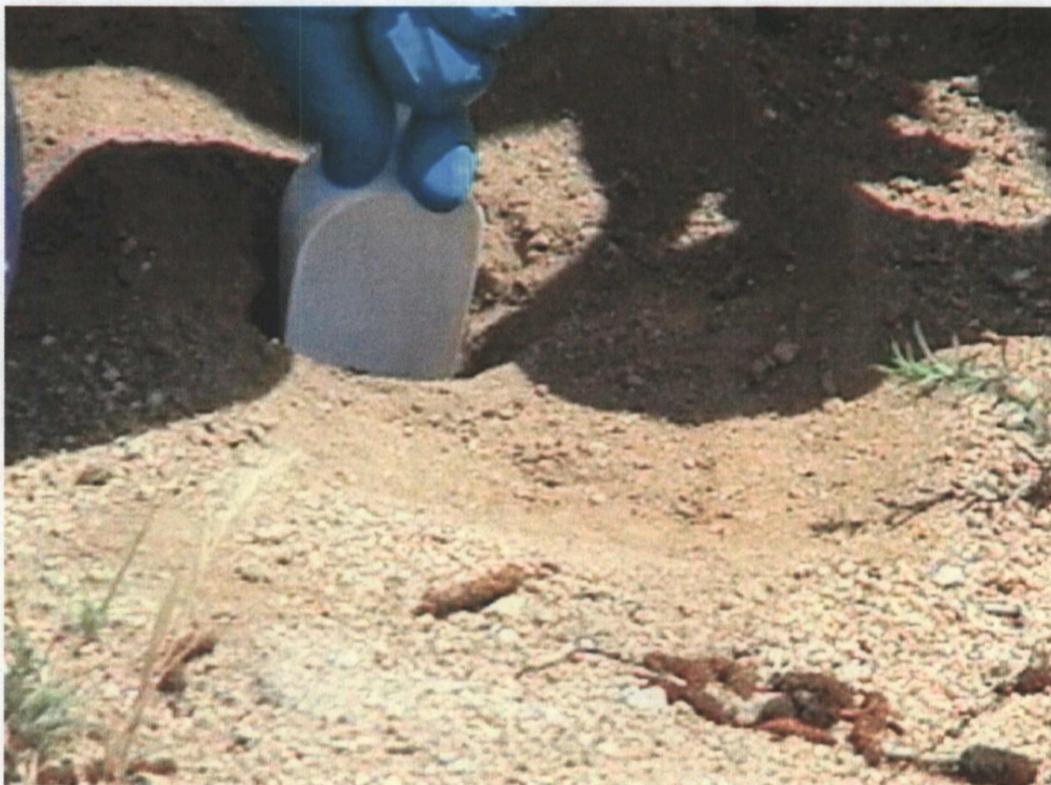
Using disposable
scoopers to
collect surface
soil samples to
analyze for
metals.

During this Preliminary Assessment (PA) project, on April 30, 2002, soil samples were collected at six (6) different locations, selected in areas formerly occupied by the hazardous waste storage area, pigment storage area, fence line (suspected improper disposal area), and drum/tub rinsing area. At each location, a sample was taken at the surface and at approximately one (1) foot bgs. Three (3) additional sample were taken in areas not suspected of being impacted by facility operations to evaluate site-specific background for metals. For one of these locations, an additional sample was taken as a field duplicate sample to test for variability and quality assurance and quality control (QA/QC) of the analytical methods used.

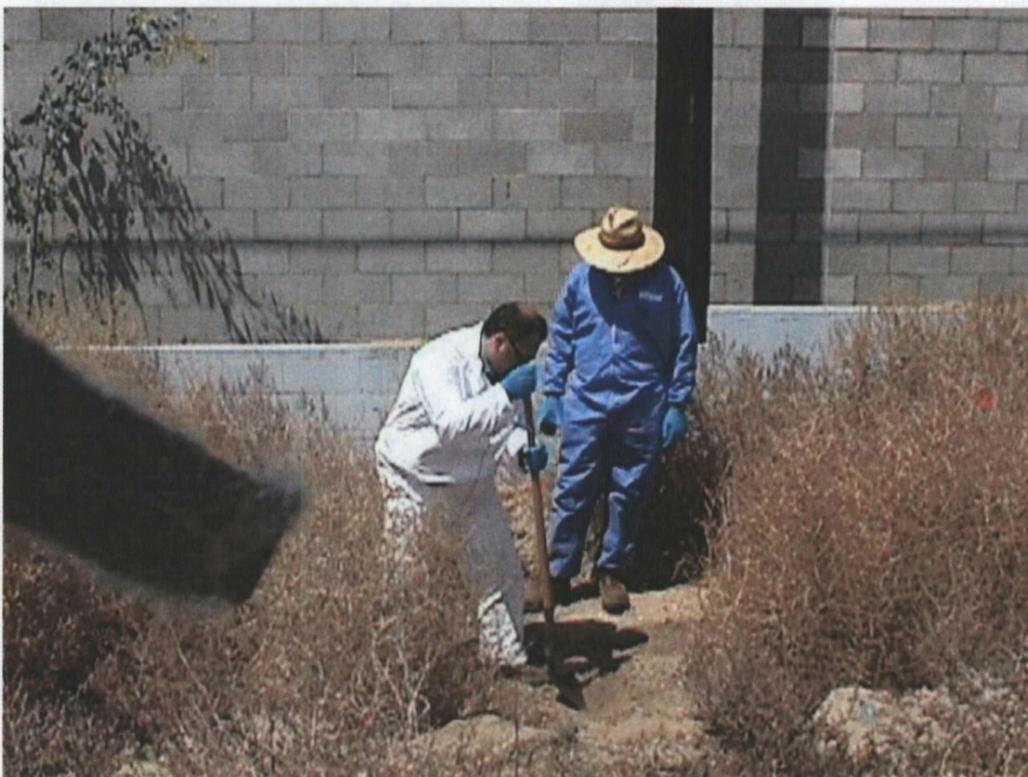
Shovel used to
collect soil
samples at 1 foot
deep at the
former Devoe
facility.
